THE HANFORD SITE

Tank Integrity Program Update on SX Farm Tank Domes Under Observation

Washington River Protection Solutions

November 17, 2021

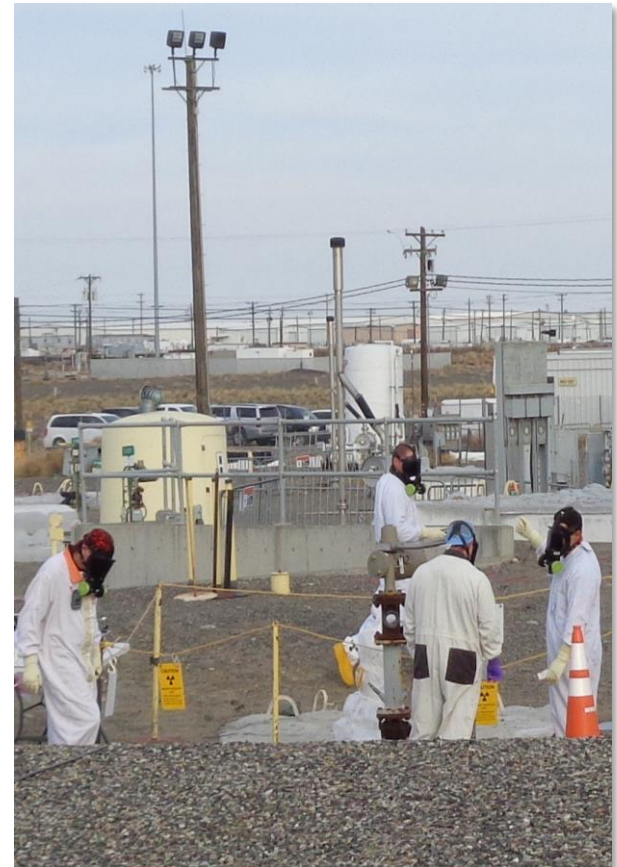
Visual inspections of the inside of single-shell tanks are a key part of the tank integrity program.

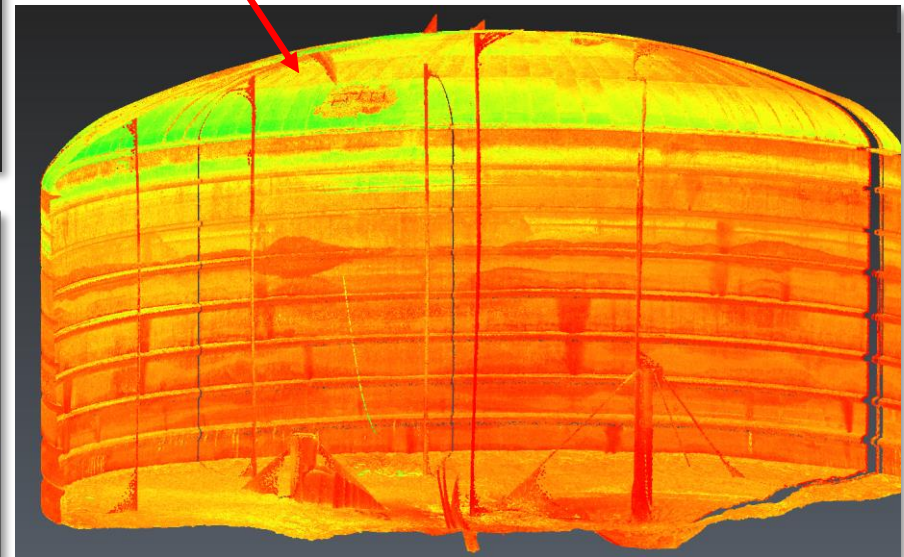
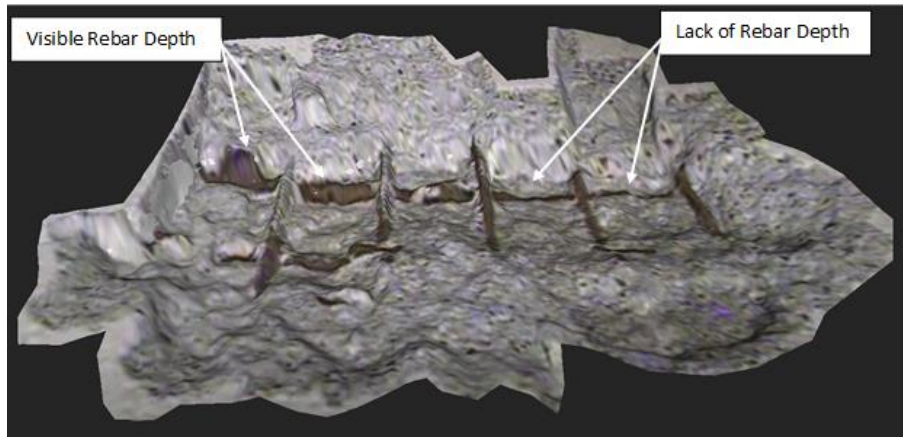
Spalling location on the dome

The figure consists of two side-by-side images. The left image is a technical drawing of a dome shell, showing a grid of reinforcement bars (rebar) and a curved surface. A yellow dashed circle highlights a specific area of the dome. The right image is a photograph of the actual construction, showing the same dome shell with reinforcement bars. A yellow dashed circle highlights the same area as in the technical drawing. Arrows connect the design elements to the construction elements. The technical drawing includes labels such as 'R=35.4 ft', '12 inch', and '9.5 inch'. The photograph includes labels such as '12 inch', '9.5 inch', and 'Top of Steel Liner'.
